STATUS REPORT FOR THE SUBMERGED REEF BALL™ ARTIFICIAL REEF SUBMERGED BREAKWATER BEACH STABILIZATION PROJECT FOR THE GRAND CAYMAN MARRIOTT HOTEL

performed by Lee E. Harris, Ph.D., P.E.
Consulting Coastal Engineer
Assoc. Professor of Ocean Engineering
Florida Institute of Technology
Melbourne, Florida 32901 USA

August 2003

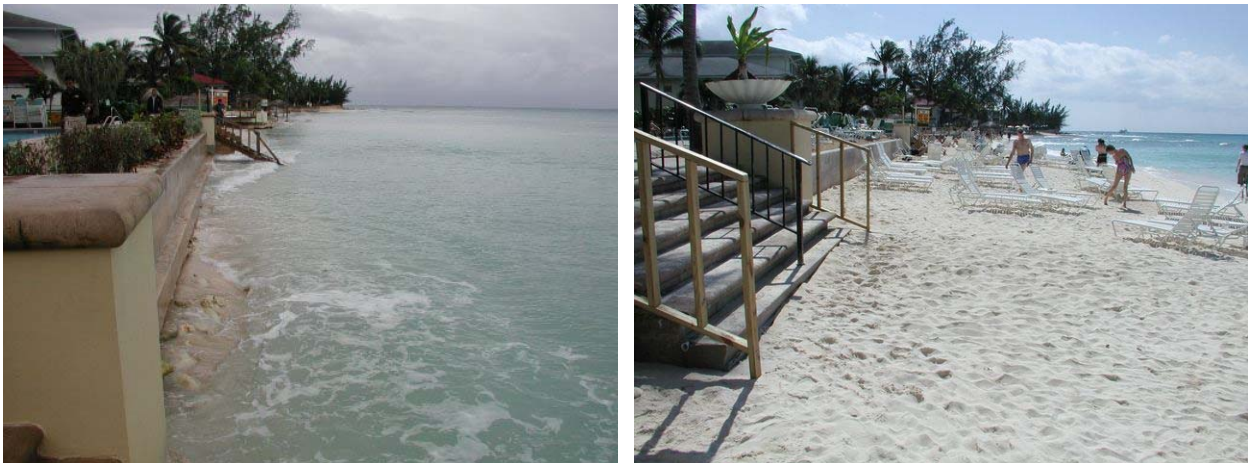
Figure 1. Before and After Breakwater Installation Photographs – View South
October 2002 (left) and February 2003 (right)

Initial field inspections at the Grand Cayman Marriott Resort were first performed in February 2002 to investigate the beach erosion problem at the Marriott Hotel at the southern end of Seven Mile Beach on Grand Cayman Island, and to determine alternatives for restoring and stabilizing the beach at this site. An array of alternatives was considered, and a submerged breakwater constructed of 200 Reef Ball™ artificial reef units was chosen. Design and permitting of the project was performed during the winter and spring of 2002, with fabrication of the units and deployment offshore completed in November 2002. Figures 1 and 2 show the accretion of the beach following installation of the Reef Ball breakwater.

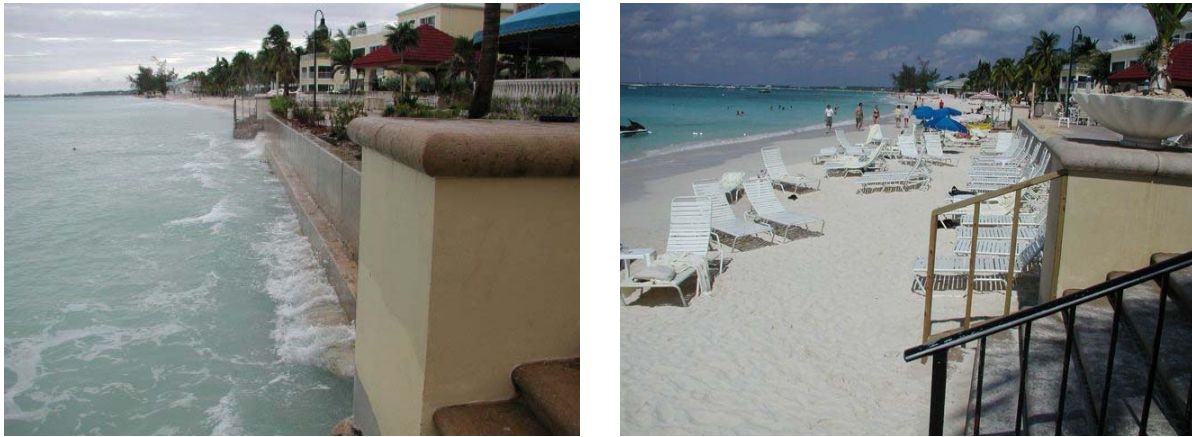
Figure 2. Before and After Breakwater Installation Photographs – View North
October 2002 (left) and February 2003 (right)

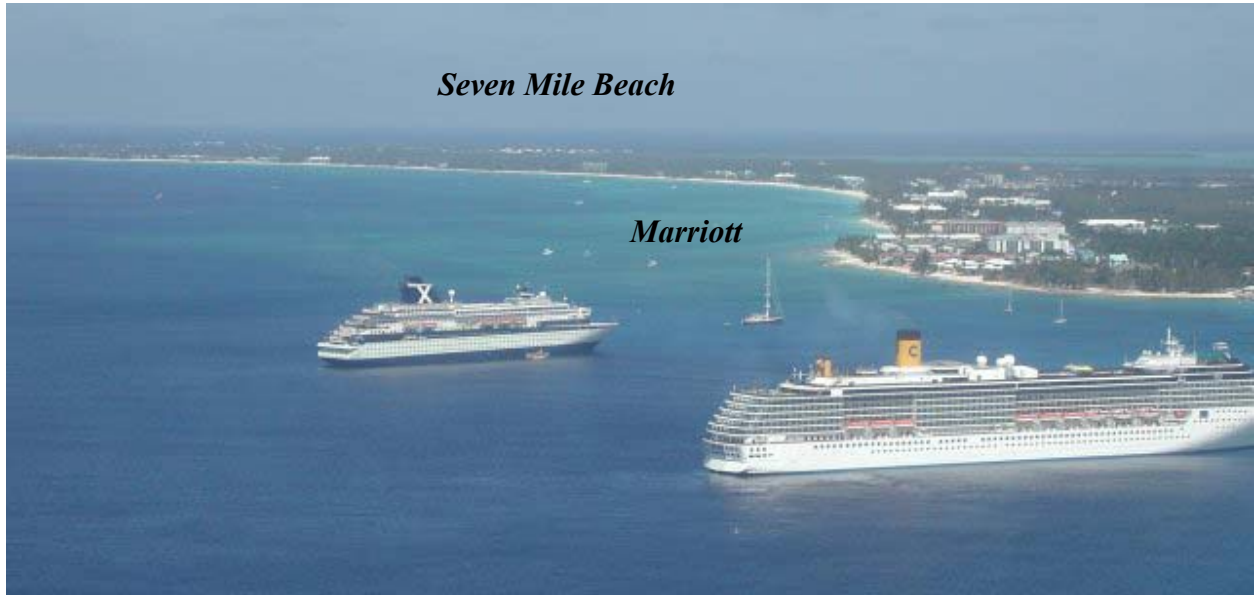
The Marriott Hotel lies near the southern end of Seven Mile Beach. The aerial photograph in Figure 3 shows a view north from the Port, with the locations of Seven Mile Beach and the Marriott Resort indicated. The beaches in the Seven Mile Beach area generally become wider as one travels north from the Marriott Hotel to the central Seven Mile Beach area, while to the south there is only a short stretch of sand beach that is followed by a rocky shoreline as you approach the Treasure Island Resort. There also are some rock groins that were constructed in this area, as shown in Figure 4, and the shoreline here curves around to the east into the Port area. This rocky shoreline to the south of the Marriott, the reorientation of the shoreline, and the rock shoreline with no sediment source to the south prevents any potential natural transport of sand from the south to the Marriott's beaches.

Figure 3. Aerial View North from the Port towards Seven Mile Beach

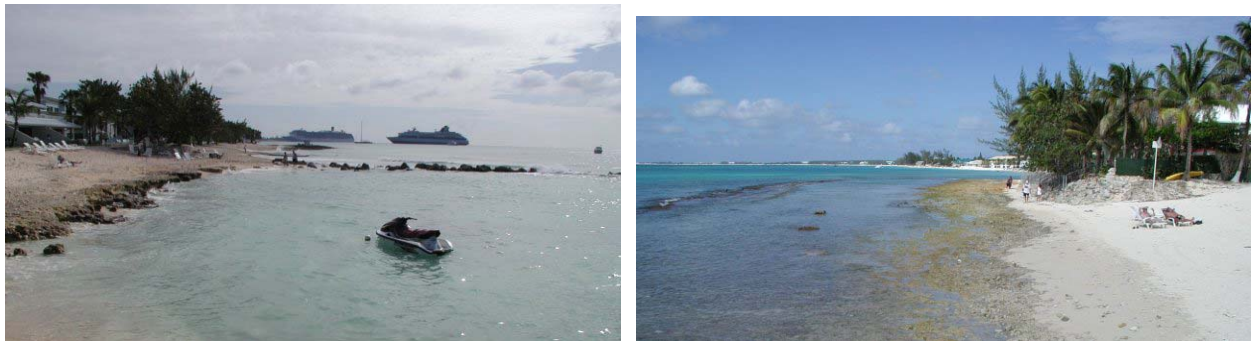
Due to the erosion of the beaches along the southern reach of the Seven Mile Beach area, natural sand accretion and return of the beach width to that in the mid 1990's could take several years, if at all, and any future southwest wave events will further erode the beaches in this area, and slow this natural recovery. The beaches in the Seven Mile Beach area have been continuing to narrow in recent years. Waves from tropical storms and hurricanes, such as Hurricane Michelle in November 2001, and again during storm events in 2002 and 2003, have resulted in increased transport of sand to the north.

Figure 4. View SW towards the Port showing the existing Groins south of the Marriott (left); and view N towards Seven Mile Beach showing the rocky coast south of the Marriott

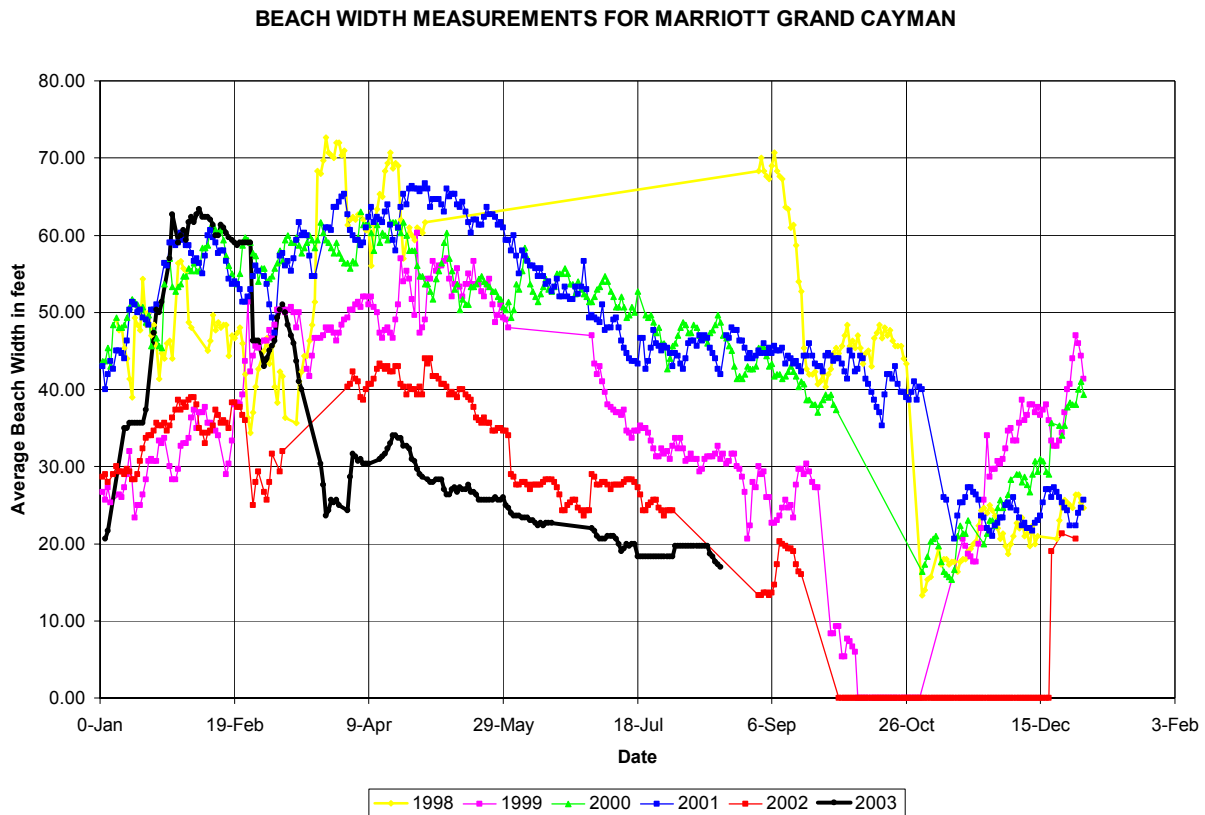
The graph in Figure 7 shows the beach width measurements for the past 6 years all on one graph, to show the variations from year to year. This graph shows the seasonal changes in beach widths and the variations from year to year depending on the variation in oceanographic conditions. For example, waves impacting the Seven Mile Beach area from Hurricane Michelle in November 2001 reduced the beach width at the Marriott from an average of 40 feet to 20 feet, with some recovery after the storm with beach widths varying from 20 to 28 feet. In September 2002 waves reduced the beach width from 20 feet to zero, and the beach width did not recover until after the Reef Ball breakwater was completed in November 2002.

Figure 7. Beach Width Measurements showing Seasonal and Annual Variations

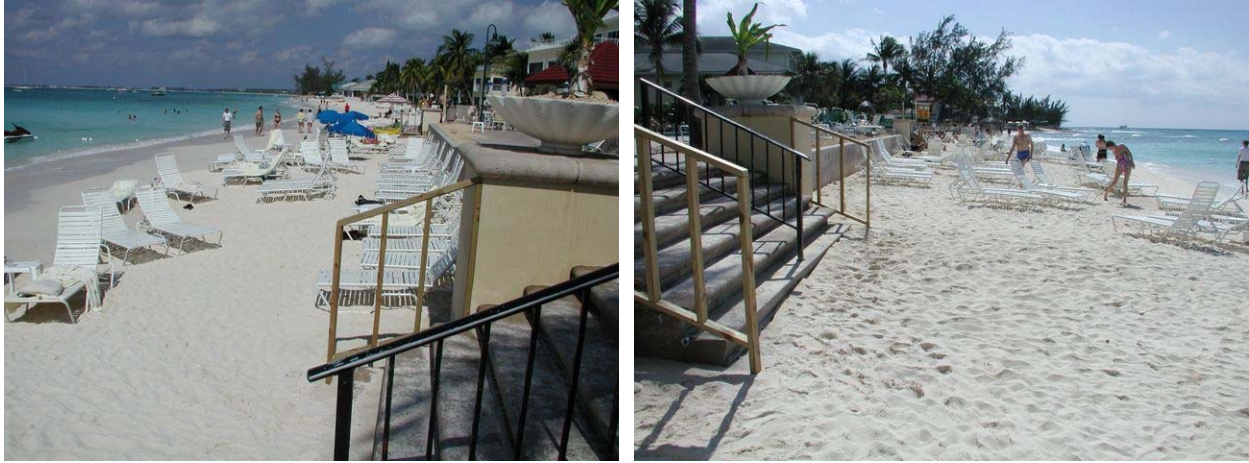
The photographs in Figure 9 taken in February 2003 show the condition of the beach, which increased in width from zero to over sixty feet wide, following the installation of the Reef Ball breakwater. Over 200 Reef Ball units were installed in the design template, with top elevations near but below the normal low tide elevation as designed and permitted, and shown in the photographs in Figure 10 and 11.

Figure 9. Views North (left) and South (right) of the Marriott Beach in February 2003

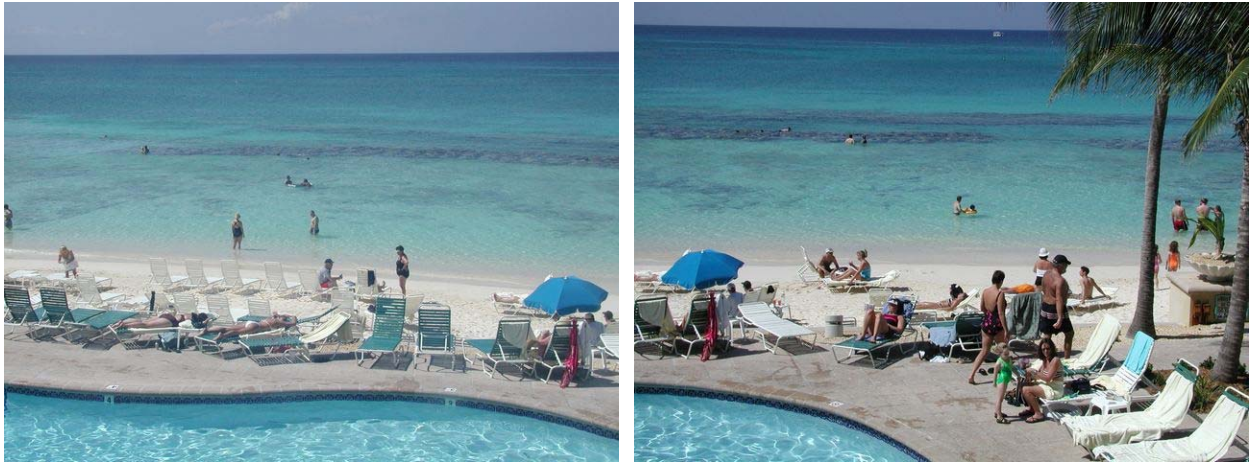
Figure 10. February 2003 Photographs showing the offshore Reef Ball Breakwater

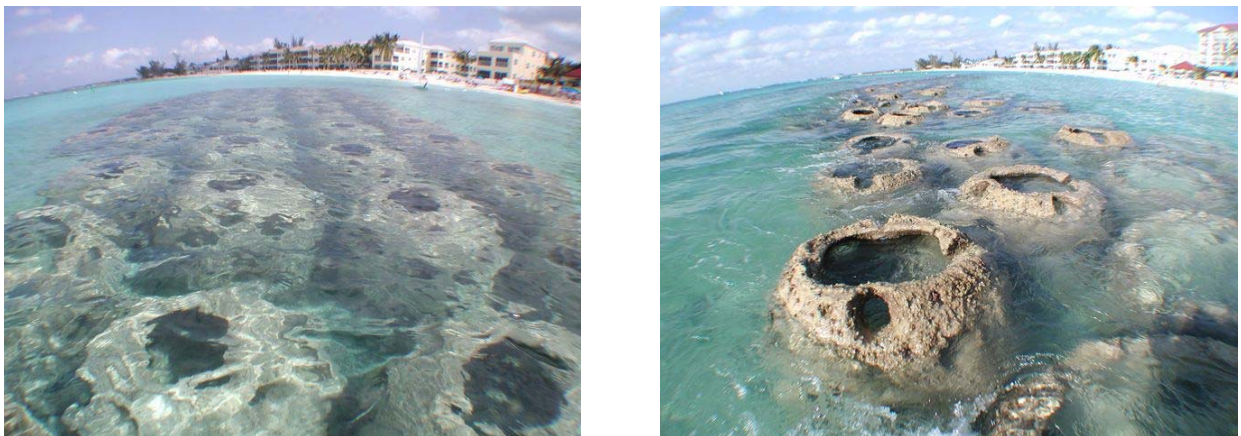
Figure 11. Northern (left) and Southern (right) Reef Ball Artificial Reef Submerged Breakwater Segments at Extreme Low Tide.

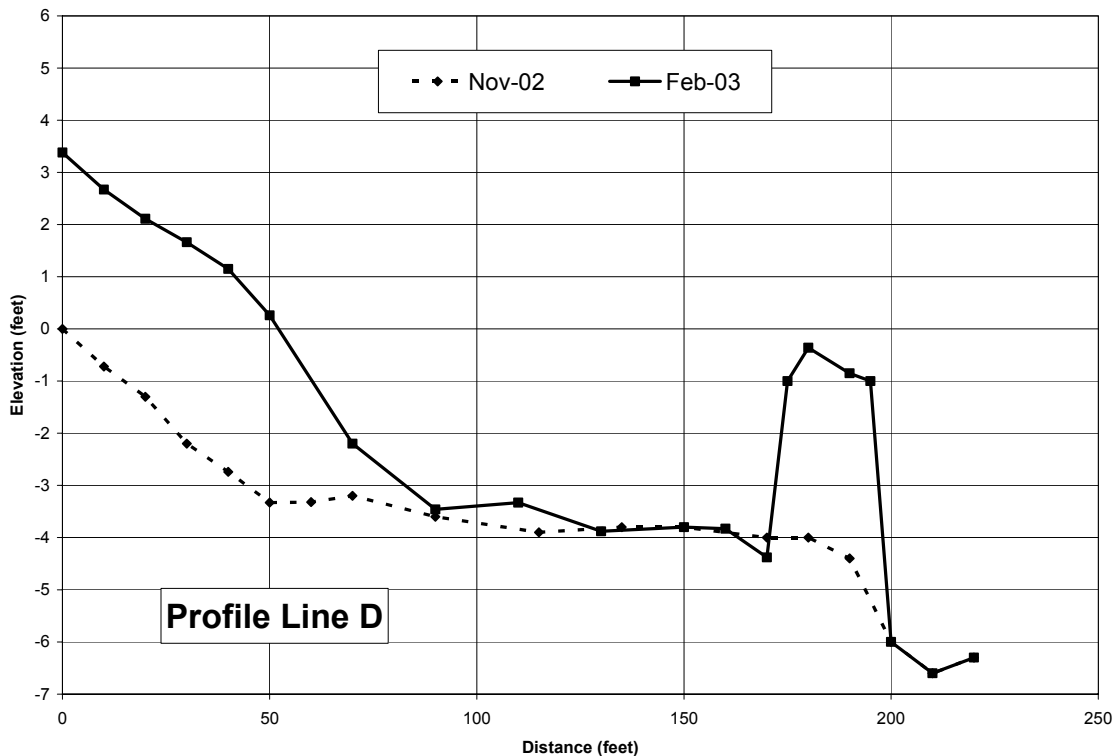
These graphs show the additional sand that accreted seaward of the Marriott seawall following the installation of the Reef Ball breakwater. The beach width increased from zero to 40 to 55 feet in width from November 2002 to February 2003, whereas the widest beach width in all of 2002 was 45 feet. Recent summer seasonal wave action has reduced the beach widths to an average of 19 feet at the Marriott (but even less at adjacent beaches in the area), and the current tropical storm and hurricane season may further erode the beach. However, the completed Reef Ball breakwater (and extension if added) is designed and has served to minimize the beach erosion and assist with the stabilization of the beach at the Marriott.

Figure 16. Profile Line D – 130 feet North of Southern End of Reef Ball Breakwater
