BEACH CONDITIONS & STABILIZATION ALTERNATIVES FOR TAMARIND BAY CONDOMINIUM, GRAND CAYMAN

performed by Lee E. Harris, Ph.D., P.E.
Consulting Coastal and Ocean Engineer
Assoc. Professor of Ocean Engineering
Florida Institute of Technology
Melbourne, Florida 32901 USA

June 2003

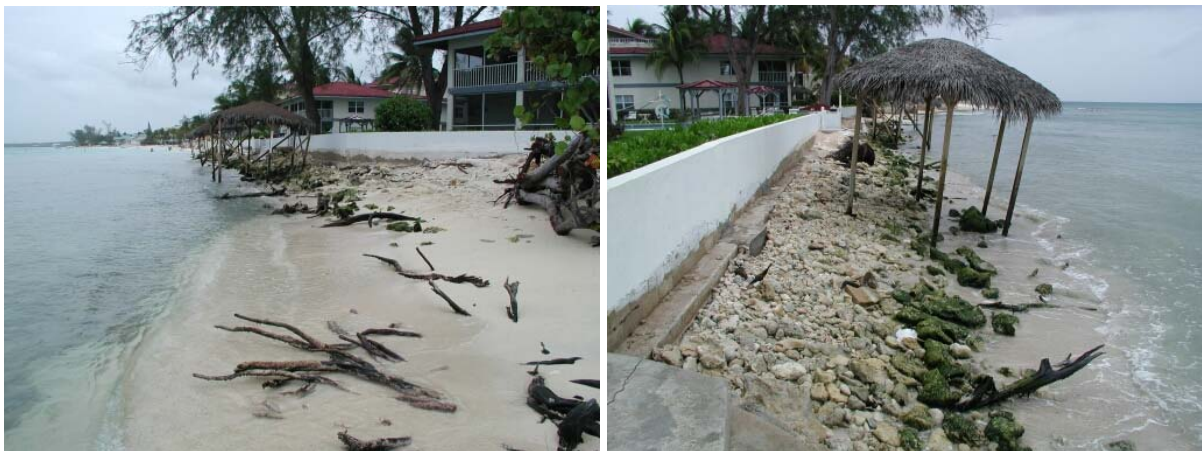
Figure 1. Views North (left) and South (right) of the Tamarind Bay shoreline.

Site investigations were performed on May 26 to 28, 2003. This included inspections and photographs of the beach areas at the property (see Figure 1), and the beach areas to the south and north along Grand Cayman's Seven Mile Beach western shoreline. Historical information and photographs of the shoreline were reviewed.

The December 2002 aerial photograph in Figure 2 and cross-sections shown in Figure 3 show the narrow beach depicted in the photographs in Figure 1. The bottom offshore is comprised of sand and rocks, with a natural reef lying approximately 175 feet offshore of the seawall.

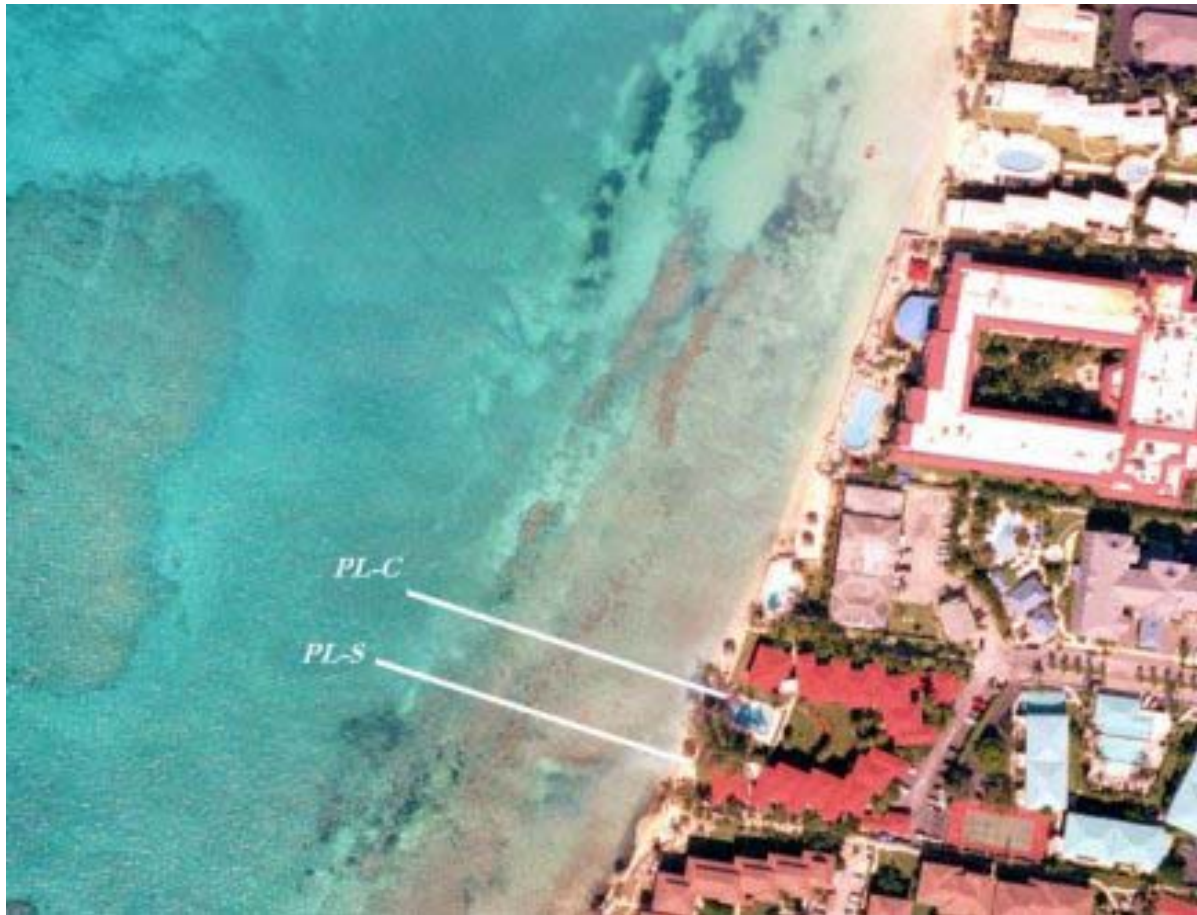
Figure 2. December 2002 Aerial Photograph showing the 2 Surveyed Profile Lines

The two profile lines were surveyed from the seawall running perpendicular to the shore at the center and southern areas of the property. The measured water depths were adjusted to reflect the beach and sea bottom elevations relative to normal low tide conditions. The profile line locations are shown in the December 2002 aerial photograph in Figure 2, and the cross-sections for the two profile lines are shown in Figure 3.

The recently completed Reef Ball submerged breakwater offshore of the Marriott can be seen in Figure 2, with a natural reef lying further offshore. The Reef Balls are located approximately 160 feet offshore of the Marriott seawall, and the natural reef is located approximately 220 feet offshore of the seawall.

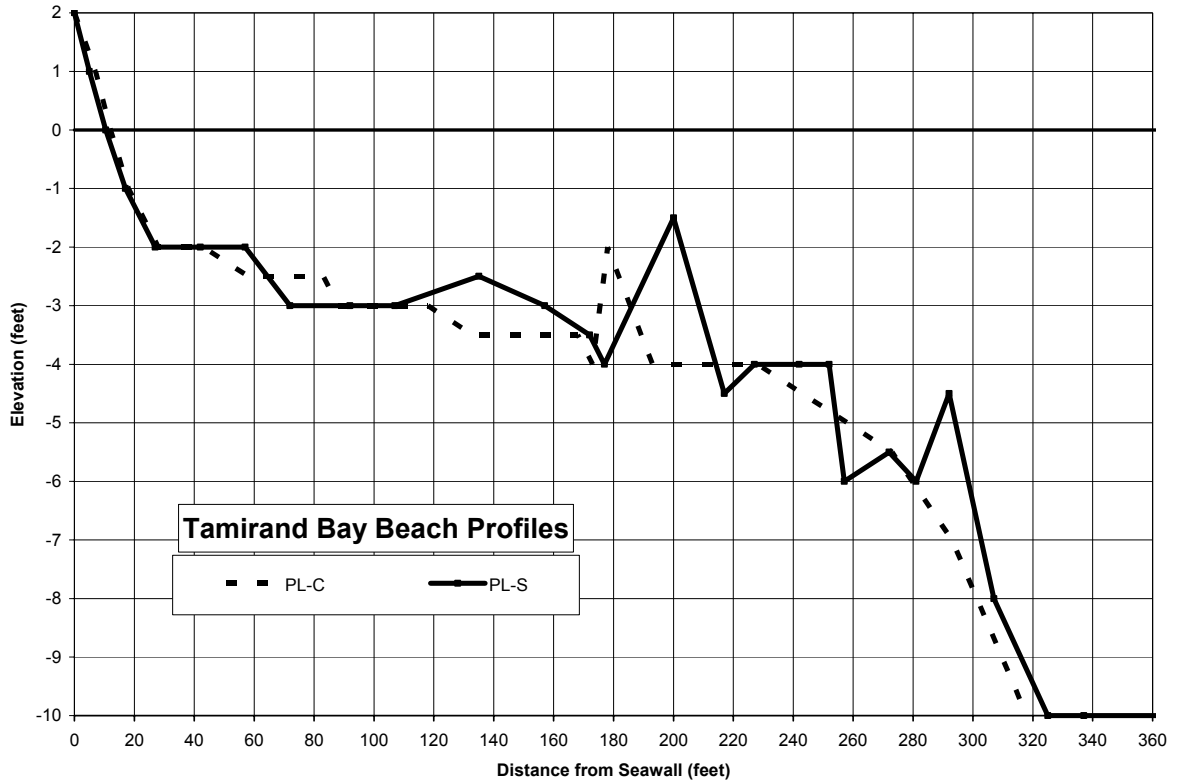
Figure 3. Beach Profile Lines Surveyed May 2003

The beach profiles shown in Figure 3 show relatively shallow water depths predominantly 3 to 3.5 deep from 75 feet offshore to the reefs that start at 175 feet offshore. The three beach profiles surveyed offshore of the Marriott in February 2002 (labeled north, center and south and shown in color) are shown together with the two Tamarind Bay beach profiles surveyed in May 2003 (labeled PL-C and PL-S and shown in bold and dashed black lines) in Figure 4, to show the differences in water depths and offshore reefs in these 2 locations.

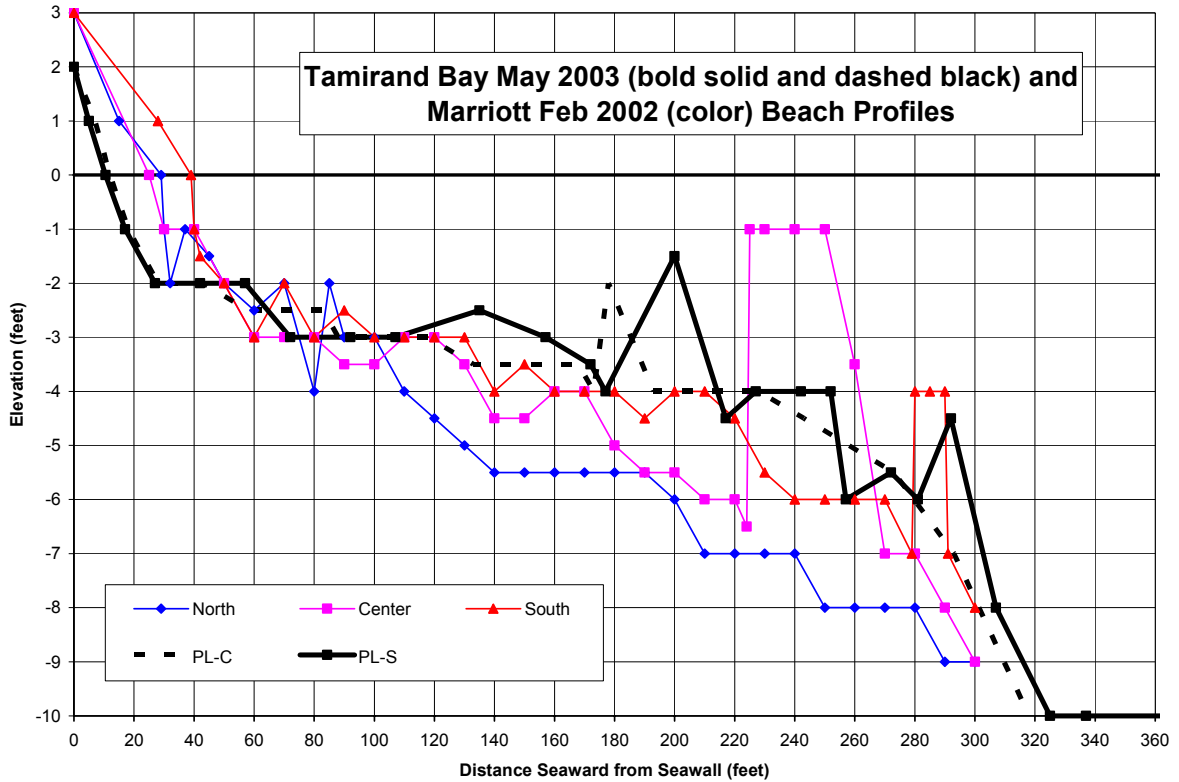
Figure 4. Tamarind Bay and Marriott Beach Profile Lines

Figure 4 shows that landward of the natural reef (distances 140 to 170 feet from the seawall), the water depths are 4 to 6 feet at the Marriott, but only 2.5 to 3.5 feet deep at Tamarind Bay. This indicates that the 4'-high Ultra Ball size Reef Ball units used for the Marriott are too tall to be deployed as submerged breakwater units at the same offshore distance at Tamarind Bay. Therefore smaller 3'-high Pallet size Reef Ball units could be used if a similar submerged breakwater system is installed for the Tamarind Bay and/or adjoining properties.

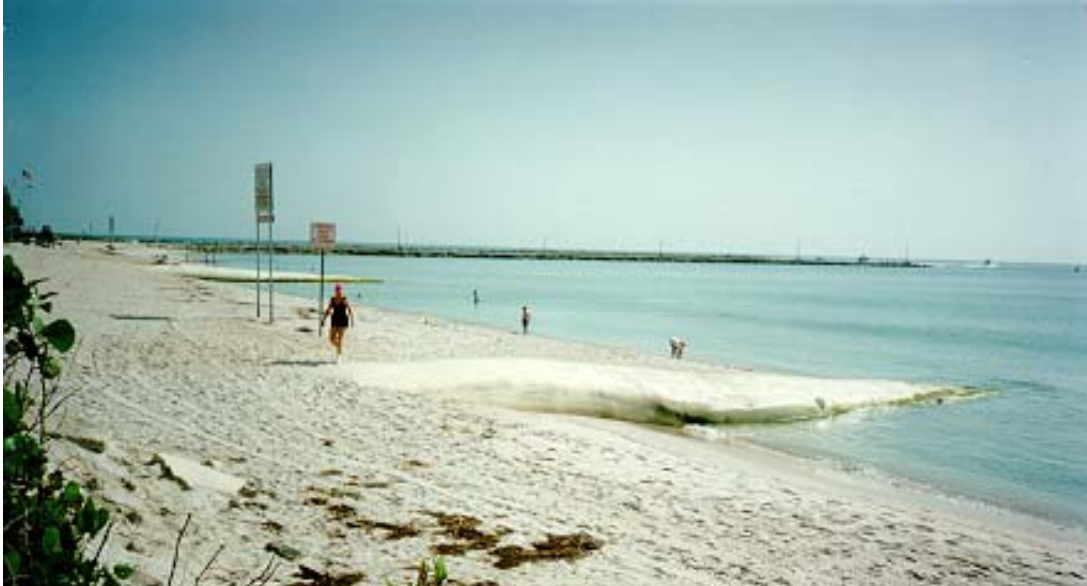
Figure 6. Sand-filled Groins Stabilizing a Florida Beach

groins can impede pedestrian travel along the beach, so that the use of a design such as sand-filled containers shown in Figure 6 to form the groins should be considered to allow pedestrian travel across them.

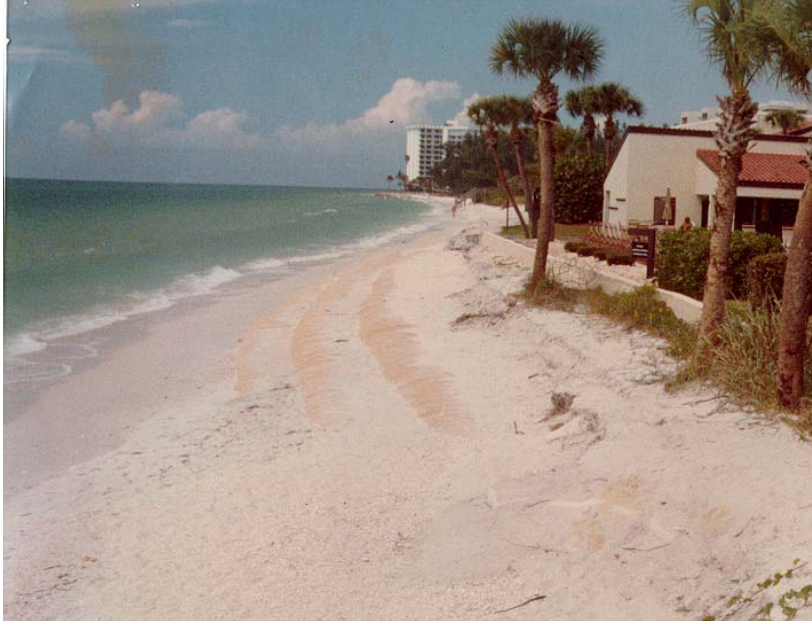
Figure 7. Sand-filled Container with Step-face

Another method to assist with holding sand on the beach is to install a shore parallel structure seaward of the seawall, and fill the area between this structure and the seawall with fill. The ends of the sill structure must curve back to the seawall at the north and south ends of the property. This shore parallel structure functions as a sill to hold the sand on the beach.. The use of a step-faced sand-filled container such as that shown in Figure 7 allows pedestrian traffic along and up and down the structure when it is exposed.
